ENVIRONMENTAL MANAGEMENT PLAN

PORT OF BAHÍA BLANCA

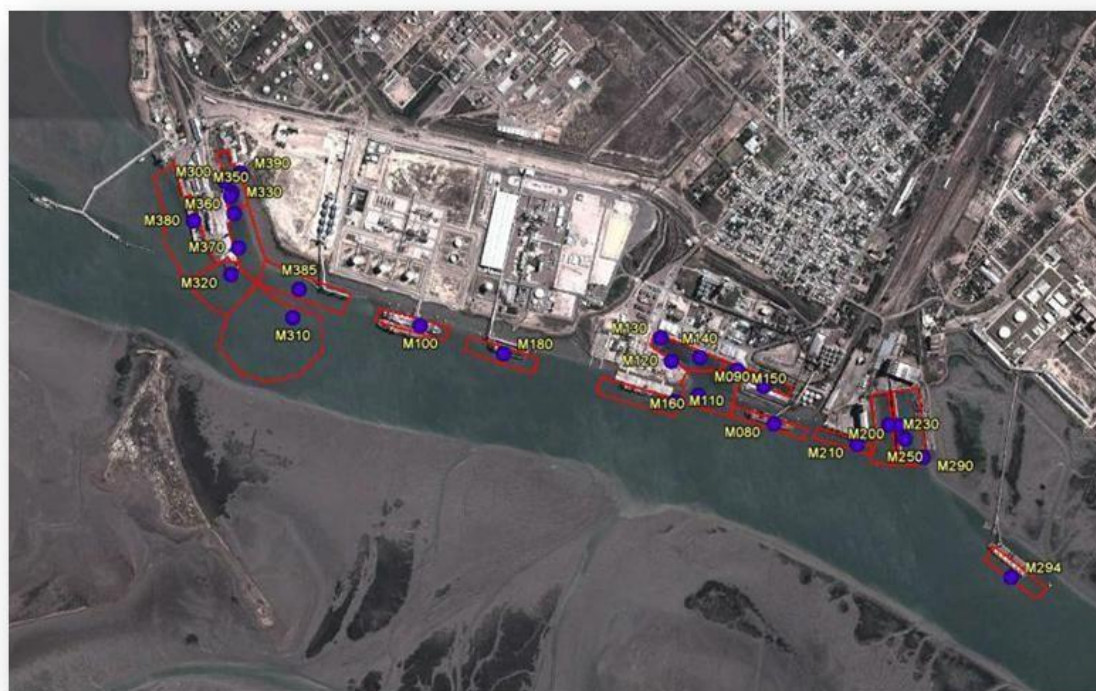
The Monitoring plan has a three-month frequency and makes it possible to get data before, during and after dredging. The monitoring results, which are compared to existing rules in similar systems (the Netherlands, Canada, USA), have never shown intervention values throughout history. The samples corresponding to the pre-dredging, post-dredging and during dredging campaigns are performed in the mooring jetties of the Puerto de Ingeniero White, Puerto Galván, Puerto Rosales and the BNPB, turning circle, channel areas to be dredged and dumping areas.

M1	Berth 5/6 TBB
M2	Berth 7/8 TBB
M3	Berth 9 TBB
M4	ACCESS MMC
M6	Fishermen harbor
M7	Berth 19 MMC
M7 BIS	Jetty 20
M8	Berth 5 PG
M9	Berth 6 PG
M10	Berth 7 PG
M11	Berth 2 / 3 PG
M12	GARBAGE DUMP V1
M13	NAVAL BASE ACCESS CHANNEL
M13 BIS	Puerto Rosales
M14	BETWEEN BUOYS 23 and 24
M15	MULTIPURPOSE JETTY
M16	MEGA
M17	PROFERTIL
M18	DREDGE CANTARA
M19	LA GOLFADA

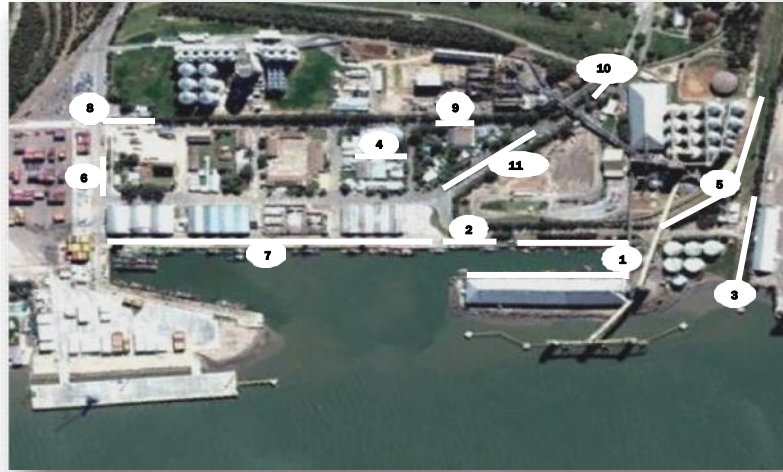
ANNUAL ANTI-RAT CAMPAIGN - INGENIERO WHITE

The campaigns are made every twelve (12) months and with a minimum frequency of one weekly visit, where control tasks are performed, baits are replaced and dead rodents are taken away. The products used should be authorized by the Secretary of Public Health of the Municipality of Bahía Blanca. The amount of baits installed is two hundred and fifty (250), distributed as shown in the pictures.

1. Fishermen harbor
2. Naval station of Prefectura Naval Argentina.
3. Access area to ex Iron Jetty
4. Foremen office yard
5. Cargill - TBB limit sector
6. Puerto Ingeniero White scales sector
7. Ministro Carranza Berth basement
8. Stowage contracting center perimeter
9. CGPBB personnel car parking area
10. Guard post PNA No. 5
11. Square (boulevard) Avda. Mario Guido
12. Puerto Galván, scales and Berths 6/7 closing area Pto. Galván

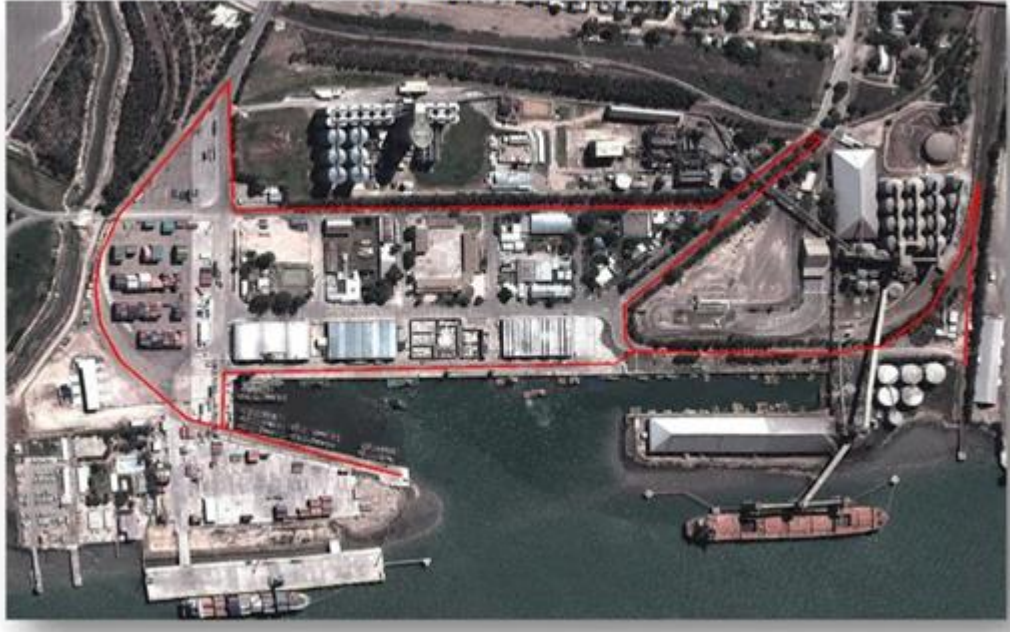
ANNUAL DESINSECTIZATION CAMPAIGN - ING. WHITE

With the focus on hygiene, the Safety and Environment area of the CGPBB has a service contracted to minimize the proliferation of larvae and to reduce the number of adult insects. These prevention campaigns against flies, mosquitoes and larvae inside the Ingeniero White port area (see picture) are performed during five (5) months, with a minimum frequency of two (2) fumigations per week, along every internal street and weed and planted areas.

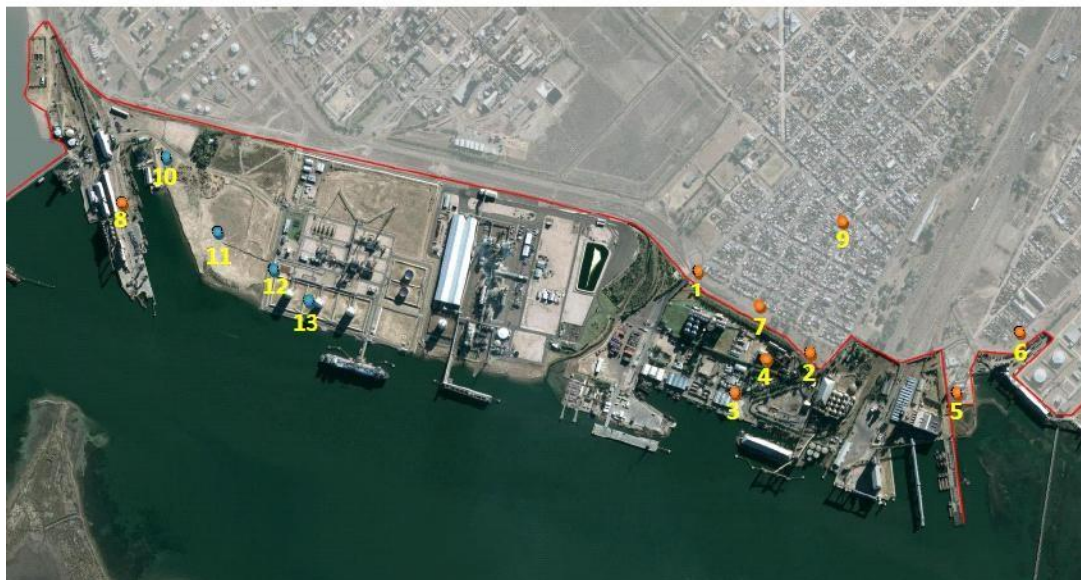
LOCATION OF PARTICULATE MATERIAL SAMPLERS

- 1 Cargill Malting plant Over fence facing traffic circle V Sarsfield
- 2 Cargill Oil plant Over fence facing gas cabin
- 3 Berth 17 By Access gate
- 4 CGPBB Garage Over fence facing the restaurant
- 5 CGPBB Berths 1-2-3-4 Over access fence
- 6 TOEPFER Over fence at Pump Room
- 7 CARGILL Malting Plant II Over fence in Avenente
- 8 CGPBB Puerto Galván Over fence by guard
- 9 FIREMEN, I. White Terrace of building on Mascarello 3845
- 10 Fishermen club (Galván)
- 11 DREYFUS (Galván)
- 12 MEGA Opposite Dreyfus truck exit
- 13 MEGA Opposite Dreyfus jetty
